Basildon Enterprise Corridor improvement

Vacuum Void Grouting

Vacuum Void Grouting implemented by Balvac improves vital access to Basildon Enterprise Corridor.

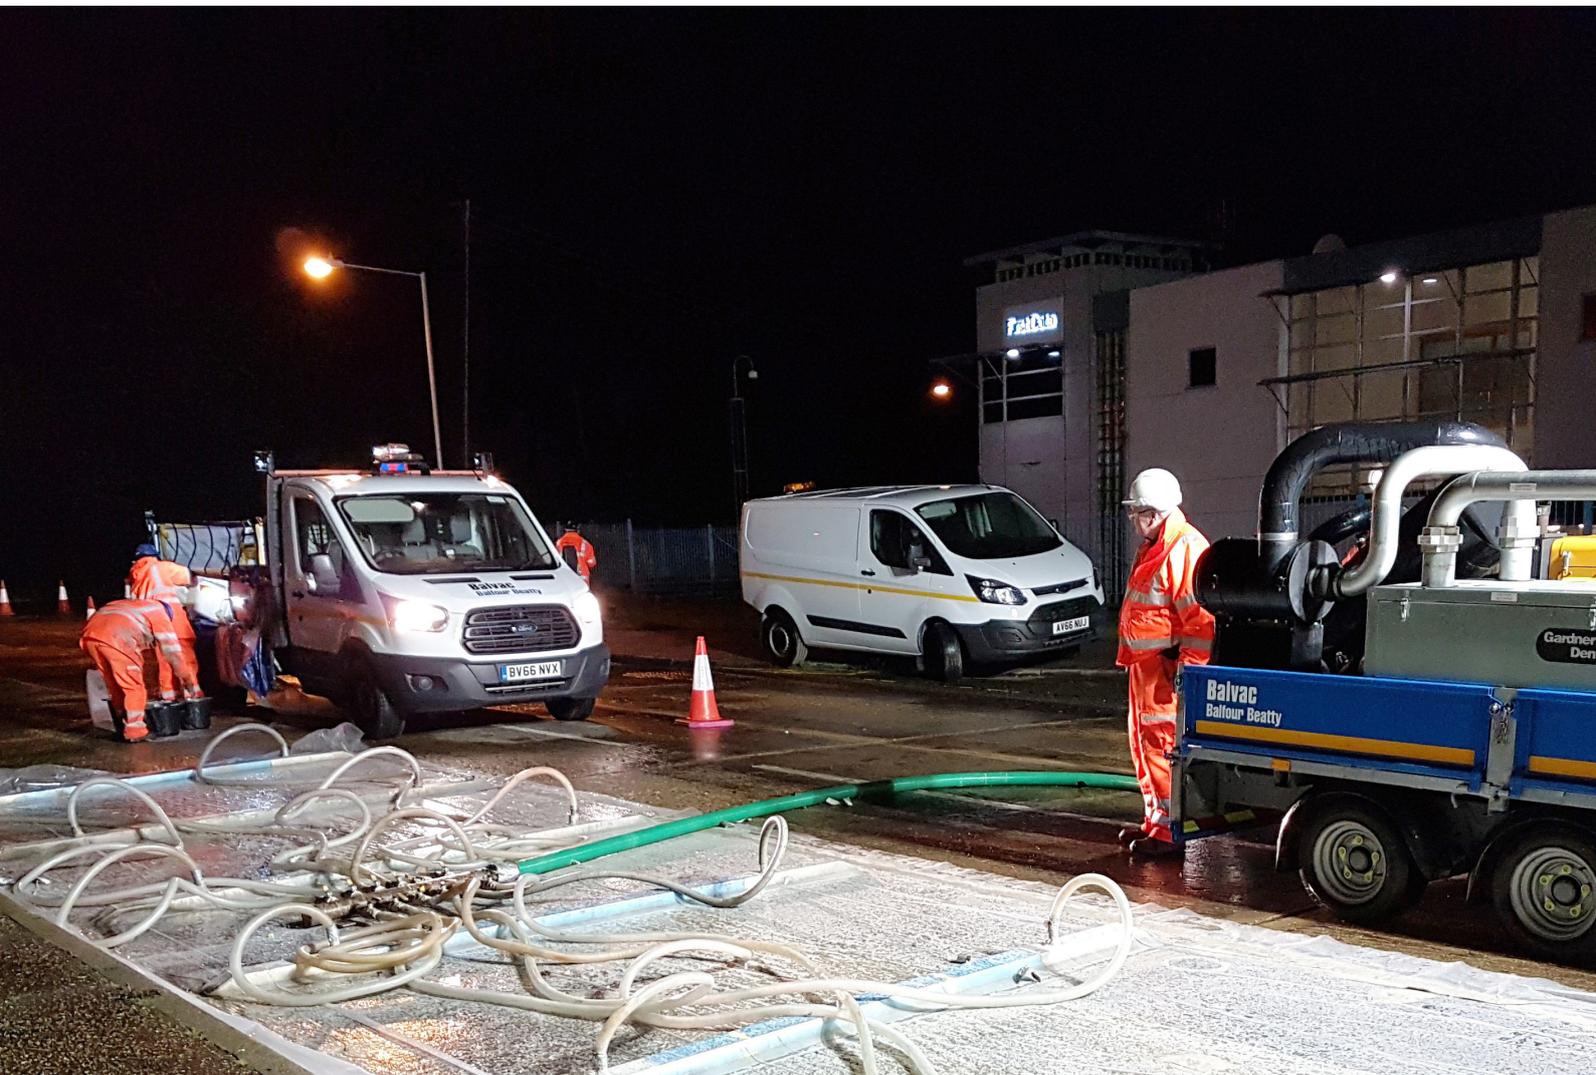
Deteriorating road surface

The concrete slabs forming the pavement had been resurfaced less than 10 years ago, but that surfacing was now exhibiting an unacceptable level of failure with major reflective cracking above joints, and even failure of repairs carried out to those joints. Something different had to be done to ensure any new road surface would achieve a longer life and not suffer from premature break-up due to movement of the underlying slabs.

Following several technical discussions with Balvac, Essex Highways opted for a comprehensive package which used a Falling Weight Deflectometer (FWD) survey to identify the most at-risk joints, followed by Vacuum Void Grouting to stabilise them, and a post-grout FWD survey to verify the degree of improvement achieved.

Vacuum Void Grouting was subsequently undertaken to the areas specified by Essex Highways, with all work being undertaken during night closures of short sections of the road. This process ensured the road was never closed during the day so local businesses and commuters experienced no disruption, delays or inconvenience.

The post-grout FWD survey of the 75 joints treated recorded a very satisfactory average improvement in joint performance of 43% and it is expected that the new overlay that has now been applied will have a correspondingly longer life expectancy.

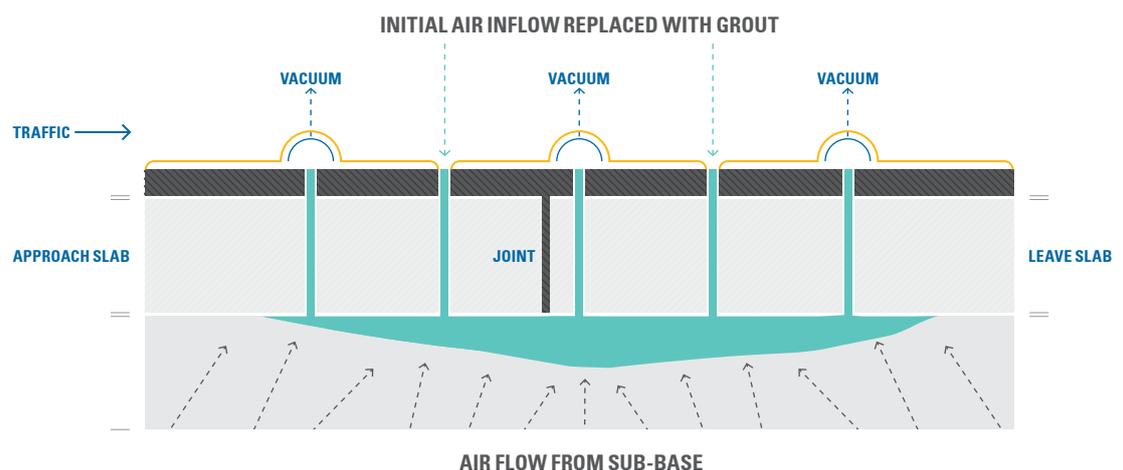
Stabilisation of slabs by Vacuum Void Grouting

Application of the vacuum creates an airflow pattern, drawing air from the sub-base and down the feeder holes. Replacing the air inflow with grout results in the filling of the void.
