# M25 Stabilising the concrete sections

Vacuum Void Grouting

## Balvac carried out specialist Vacuum Void Grouting to sections of the M25.

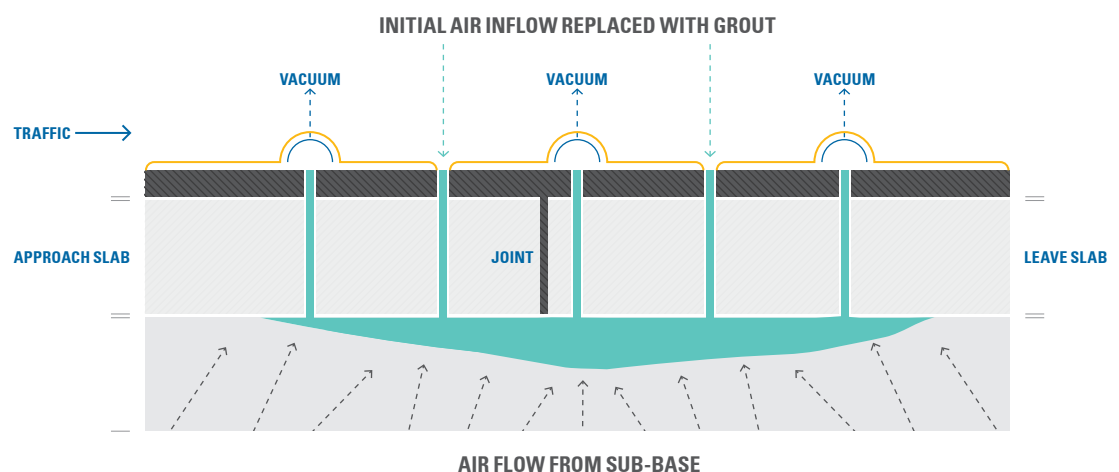
### Stabilisation of slabs by Vacuum Void Grouting

Application of the vacuum creates an airflow pattern, drawing air from the sub-base and down the feeder holes. Replacing the air inflow with grout results in the filling of the void.
