A40 Eastbound

Vacuum Void Grouting

Vacuum Void Grouting provides a long-term fix to a damaged section of the A40.

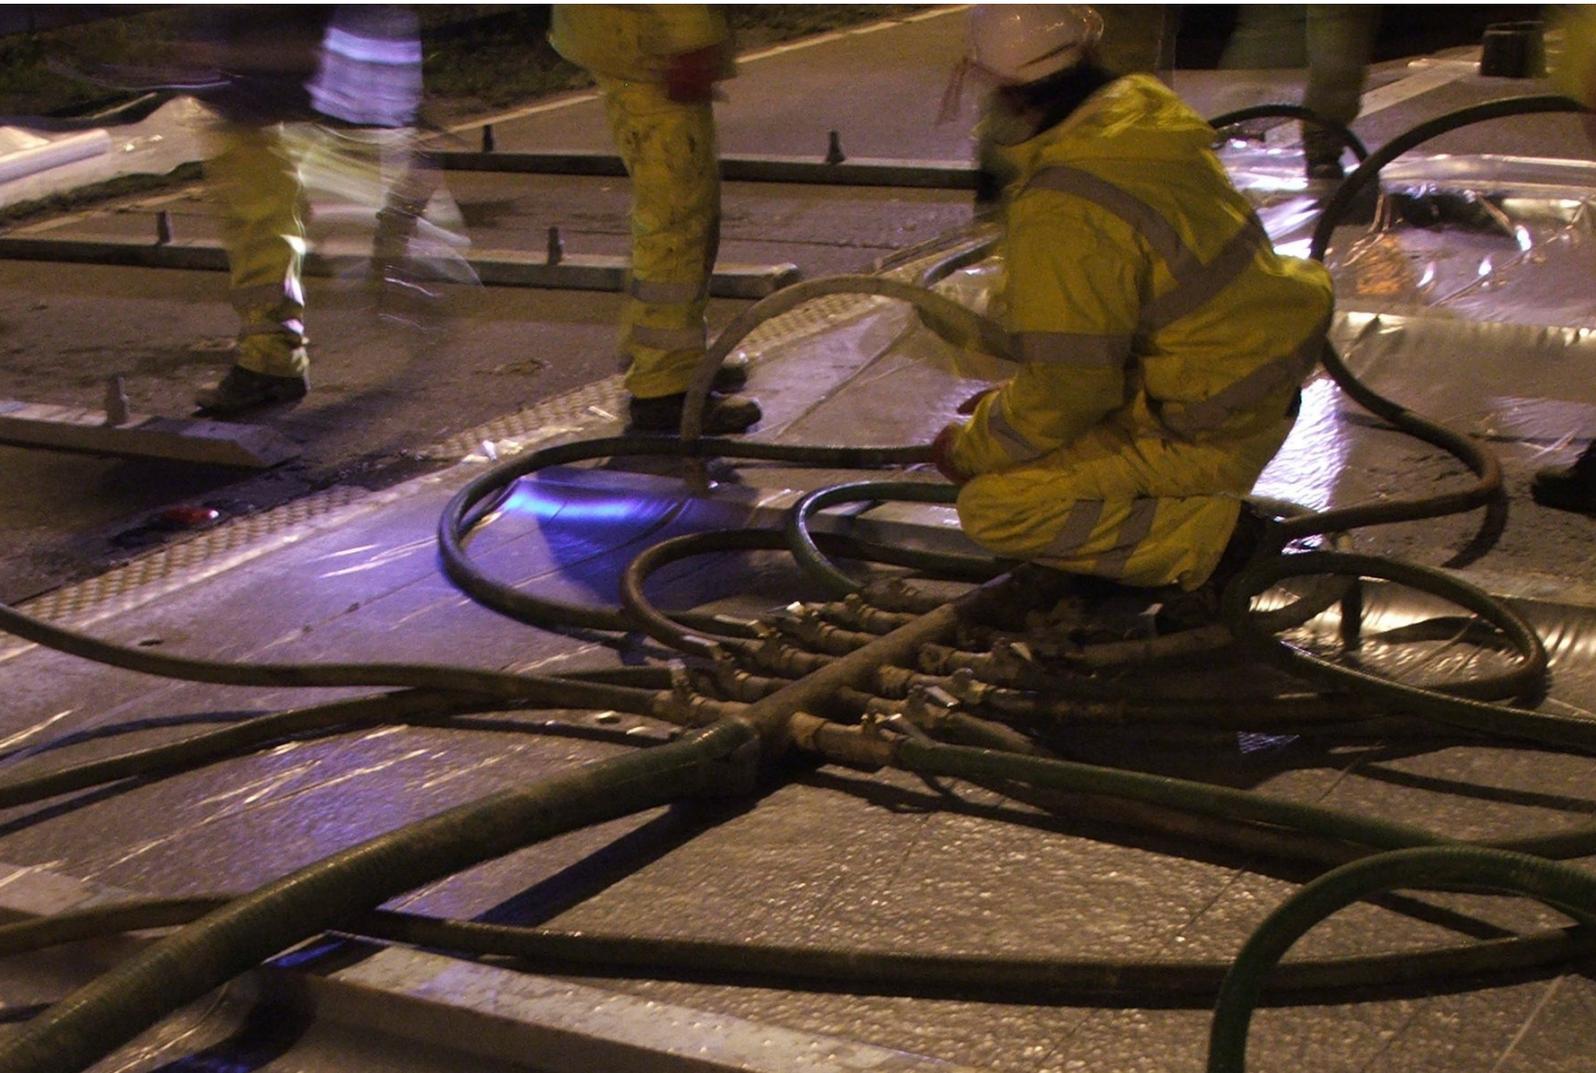
Stabilisation of slabs by Vacuum Void Grouting

The process involved drilling some 643 holes on a nominal 1m grid in the areas selected for grouting. Vacuum ducts were then placed parallel to the transverse reflective cracks over alternate lines of holes. A polythene shroud was sealed over the whole area, and a vacuum source applied to create an airflow (see diagram below).

This airflow from the surface was replaced by the introduction of resin grout to individually isolated holes between the vacuum ducts, which continued until refusal, or until resin was drawn to the holes beneath the vacuum ducts. The resin grout on average takes 3ltr/m² at 3ltr/m² (plus an inclusion of 550Kg of inert filler). This higher than normal usage clearly demonstrated the presence of voids and vindicated the client's decision to stabilise the pavement prior to overlay works. Once the Vacuum Void Grouting had taken place, the principal contractor planed off and re-laid 40mm of asphalt and all works were completed within a 2½ week period.

Balvac's Vacuum Void Grouting is specifically designed to enable the controlled introduction of a resin grout to fill small voids beneath the joints of rigid pavements. The grout stabilises and supports the construction and was selected as the best means to address the root cause of the problem at this site. By using vacuum, as opposed to pressure, this technique eliminates unwanted lifting forces and controls the grout flow. Consequently, grout is held in the targeted voids and not pumped into underground services or subgrade drainage.

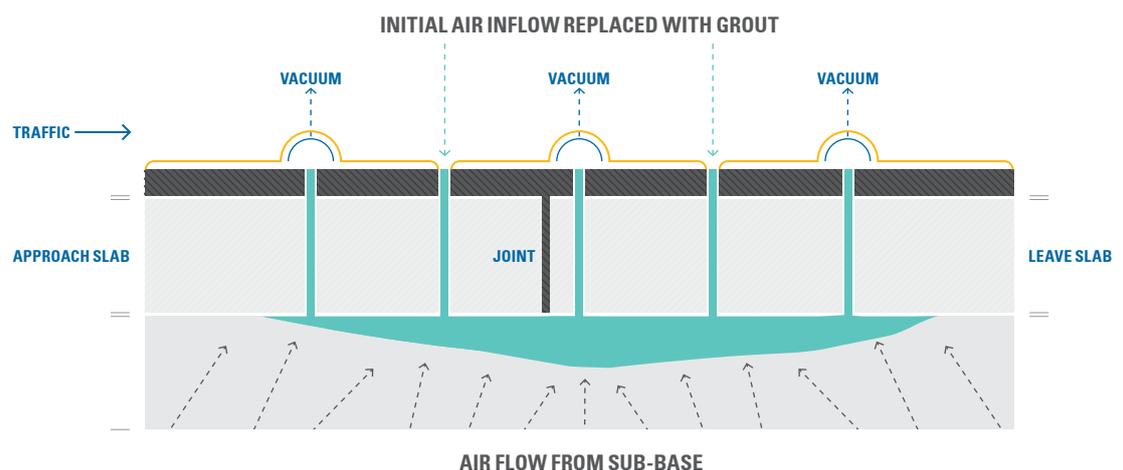
Application of the vacuum creates an airflow pattern, drawing air from the sub-base and down the feeder holes. Replacing the air inflow with grout results in the filling of the void.
